WEST SOLE PLATFORM, WA-WAP LINK BRIDGE - BRIDGE JACKING & BEARING REPLACEMENT

Project Brief

Bearing supply, bridge jacking and bearing replacement works.

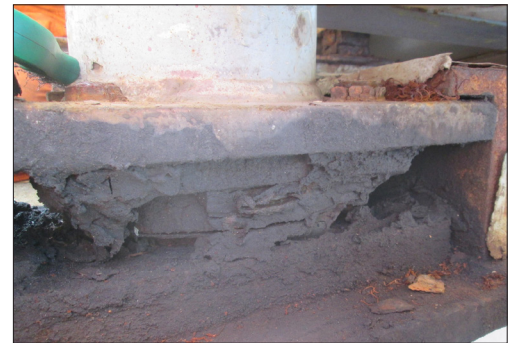
The existing bearings all appeared to be original PSC inverted mechanical pot bearings that had been supplied circa 1983. The findings revealed these bearings had reached the end of their design life and needed to be replaced. Excessive corrosion and debris to bearing fixings, uplift brackets and adjacent steelwork had caused stress on the bearings, which subsequently resulted in skew, between bridge and jacket structures inhibiting movement.

Existing bearing prior to removal shows excessive corrosion

USL Ekspan were appointed by Perenco to replace these mechanical bearings.

The inspection had confirmed a number of dimensional inaccuracies associated with the original bearings. The main dimensional differences related to the fixing hole centres and the overall base plate lengths for the WAP end bearings. USL Ekspan manufactured 4 no bespoke mechanical pot bearings (1 fixed and 3 guide) to suit the existing dimensions and load criteria. The sequential methodology for bearing replacement and careful monitoring throughout enabled successful completion of works while also maintaining restraint between the bridge and the platform.

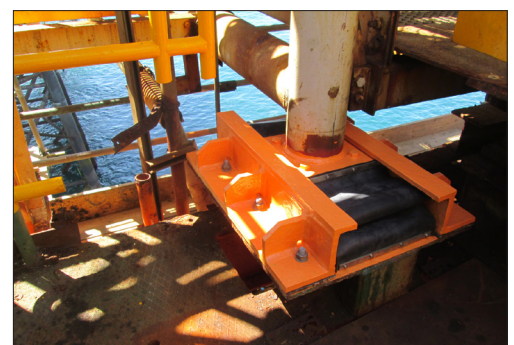
Bearing replaced complete with protective cover

To prolong the bearing life stainless steel slide plates were fully welded to the base plates, to prevent de-lamination. Protective rubber skirts were installed to protect the sliding surfaces and reduce the effects of debris ingress.
