## A689 RIVER EDEN BRIDGE, CARLISLE - CNDR BEARING REPLACEMENT & BRIDGE JACKING

### Project Brief

Design, manufacture, installation of 3 no. free and 1 no. fixed pot bearings. Design and installation of temporary works and bridge jacking.

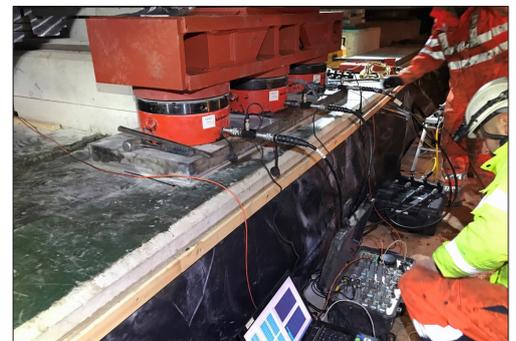
Hydraulic jacking assembly digitally monitors and controls the bridge's movement during bearing removal and replacement.

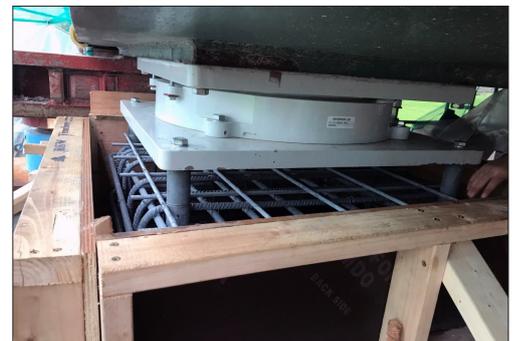
Installation of steel rebar and shuttering in place to accept pouring of concrete for the new bearing plinth.

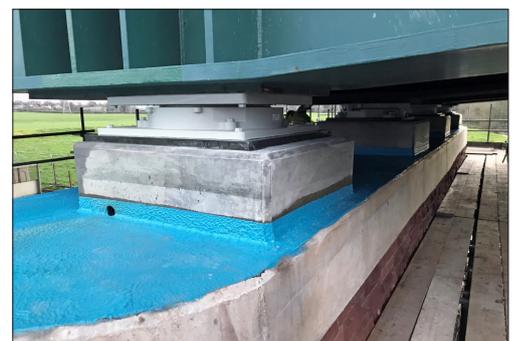
New installed pot bearings on pier top with added concrete protection.
